ADDITIONAL TROUBLE DIAGNOSIS FOR 1951 HYDRA-MATIC TRANSMISSIONS

EDITOR'S NOTE: The information on trouble diagnosis for 1951 Hydra-Matic Transmissions supplements that published in the December, 1950, Service Craftsman News, page 114.

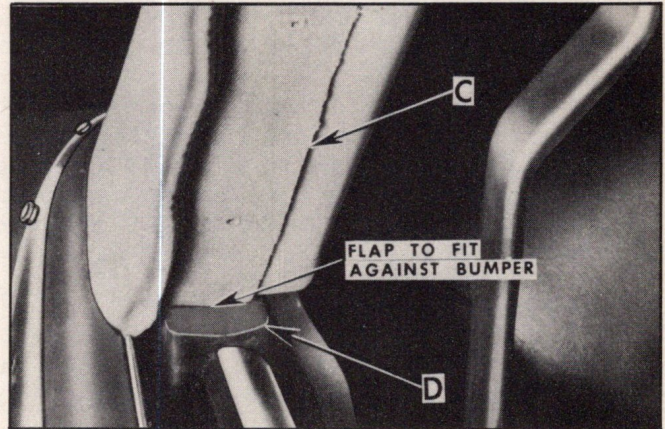
Fig. 2 Top to Hinge Bumper Fit

If the top material has pulled away in either of the locations indicated in Fig. 2, use the following repairs to improve weathersealing in this area:

1. Remove the rear quarter side roof rail weatherstrip and weatherstrip retainer.
2. Loosen the top material flap "C", from the rear quarter side roof rail.
3. Apply 3M Trim Cement to the top material flap and to the surface of the roof rail.
4. Recement and position the top material flap to the rear quarter side roof rail to obtain the proper alignment.
5. Reinstall the weatherstrip retainer and weatherstrip.

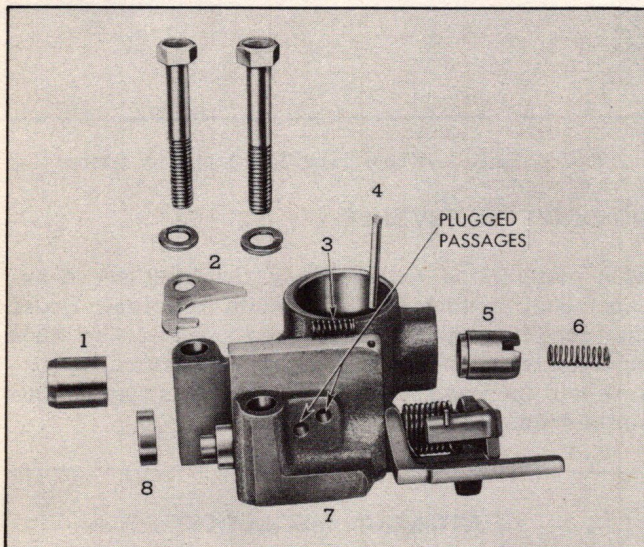
These conditions will result when one or the other of the two 1/4" cup shaped plugs are missing from the parking bracket. See Fig. 2. These plugs are not service parts and should never be removed. If plugs are loose or missing, replace the bracket assembly.

1. Referring to Fig. 2, the plug on the left closes the hole which brings main line pressure to the parking blocker piston. When this plug is missing main line pressure will be about half its normal value.

2. The plug on the right closes the hole which brings governor pressure to the reverse blocker piston. When this plug is missing up-shifts will be delayed and erratic due to low governor pressure. It would also be possible to move the selector lever to the reverse position at some speed above the normal 10 MPH (approximately) block out.

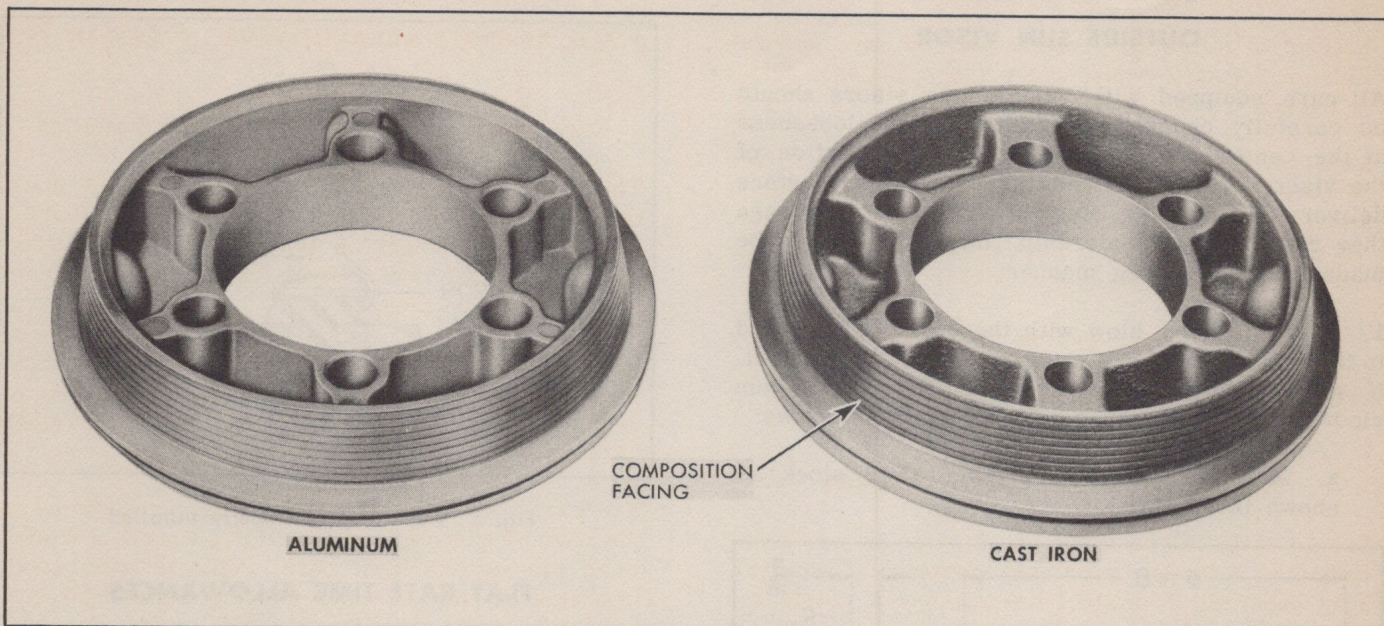
Fig. 1 Aluminum and Cast Iron Reverse Pistons

Never use the early and late types together as a severe out-of-balance condition will result.

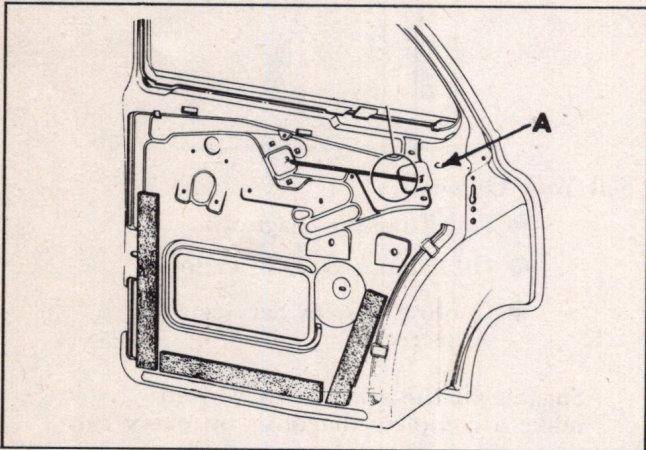
Fig. 4 Rear Door Inner Panel Construction

Should a binding rear door push button be found on 1951 Chieftain four door sedan, the difficulty is likely caused by interference between the push button lever and the door inner panel. The top edge of door trim pad should be loosened to expose the upper rear corner of the door inner panel. Insert a pry bar into slot "A" Fig. 4, and pry the inner panel away from the lock linkage to provide sufficient clearance for free operation of push button.
