ADDITIONAL TROUBLE DIAGNOSIS FOR 1951 HYDRA-MATIC TRANSMISSIONS

EDITOR'S NOTE: The information on trouble diagnosis for 1951 Hydra-Matic Transmissions supplements that published in the December, 1950, Service Craftsman News, page 114.

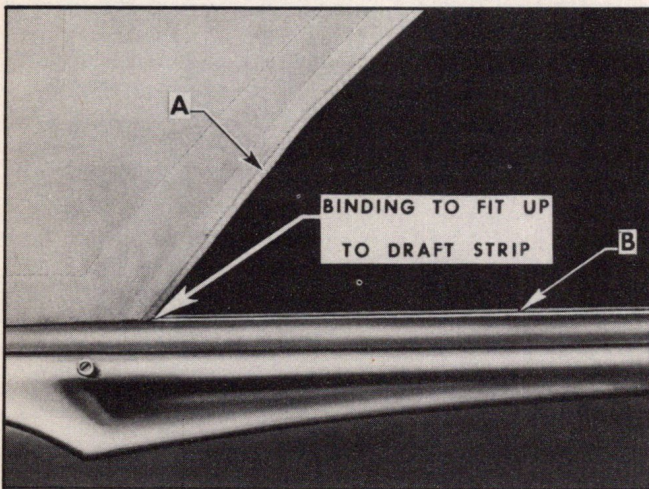
Fig. 1 Rear Quarter Curtain to Outer Draft Panel Fit

- a. The rear quarter top material side binding "A" should fit as close as possible to the rear quarter glass outer draft strip "B" as shown in Fig. 1.

1. Remove the rear quarter side roof rail weatherstrip and weatherstrip retainer.
2. Loosen the top material flap "C", from the rear quarter side roof rail.
3. Apply 3M Trim Cement to the top material flap and to the surface of the roof rail.
4. Recement and position the top material flap to the rear quarter side roof rail to obtain the proper alignment.
5. Reinstall the weatherstrip retainer and weatherstrip.

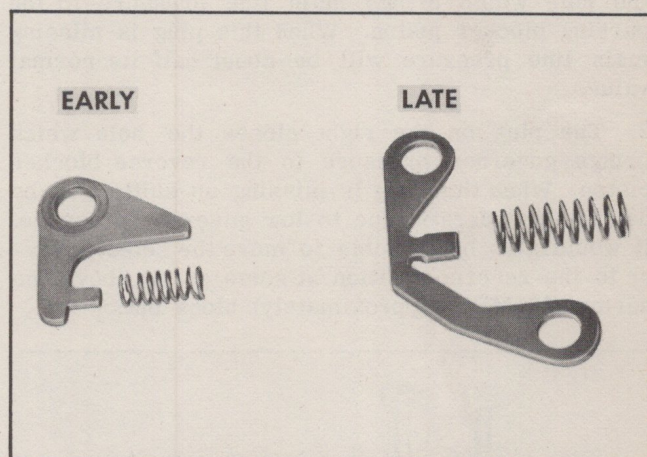
Fig. 1 Early and Late Type Spring Stop & Spring

Clicking or "ratcheting" noise in the transmission, with the selector lever in Reverse and the car moving forward 2 to 4 MPH, is due to the parking pawl trying to engage the reverse internal gear. This condition is usually the result of a sharp drop in line pressure.

2. The parking blocker piston return spring stop seat should be 1/2" to 17/32" from face of bracket. (Change the note in right hand column page 102, December 1950, Service Craftsman News.) The parking blocker return spring should never be altered. If distorted it should be replaced.

A second type spring stop and a new spring are now being used in production. The new stop has a fixed setting and is mounted under both bracket attaching bolts. The new spring has a free length of approximately 1". See Fig. 1. These parts will be stocked in GMPD warehouses and will be released on a Parts Release and Change Notice.

1. Examine reverse check valve located in detent plunger housing. Valve should be firmly attached to housing by rivet. Opposite end should extend 1/4" above face of housing in free position. Hole (.062") should line up with hole in detent plunger spacer. Face of valve should be flat against spacer when installed. Replace detent plunger retainer assembly if necessary.

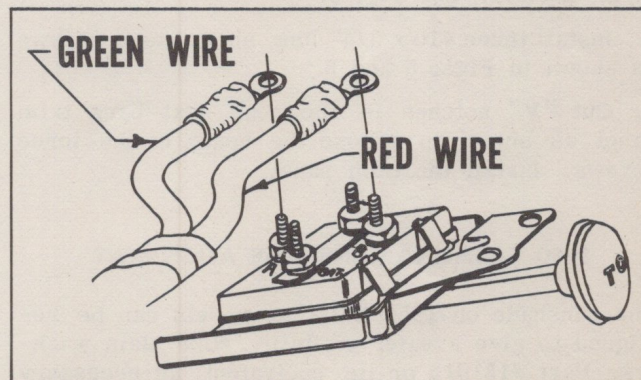
Fig. 4 Wiring Convertible Top Operating Switch

Whenever cases of reverse operation of the Convertible top are experienced, proper top operation may be secured by reworking the operating switch in the following manner: (See Fig. 4.)

1. Remove the top operating switch from the instrument panel.
2. Reverse the wiring at the operating switch so that the red wire is attached to terminal "B" and the green to terminal "A".
3. After reversing the wiring, check the operation of the folding top to make certain that it is in accordance with the information in the folding top booklet "How To Operate The Folding Top".
4. Reinstall the switch to the instrument panel.

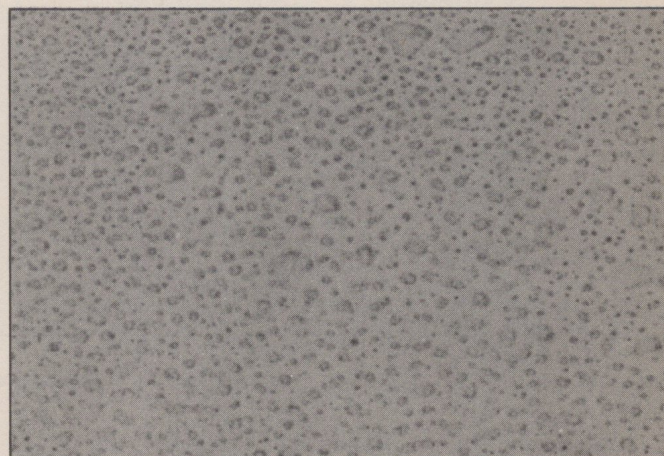
Fig. 1 Painting Over Silicone Polish

The importance of keeping the shop clean and free from the silicone on rags, clothing or spray equipment cannot be over-emphasized. Never use a gun to spray refinishing materials after it has been used to apply silicone polishes. Do not do refinishing work near an area where silicone or wax polishes are applied.

1. Apply Du Pont "Prep-Sol" on silicone polished surfaces and wipe off with clean rags before the "Prep-Sol" has a chance to dry. Change rags frequently. Do not re-use these rags any place in the shop as they will cause "fish eyes", etc., if residue from them gets on any surface which is being refinished.
2. Wet sand with #320 paper, using Dulux T-3812 Thinner.
3. Clean again with "Prep-Sol", using the same procedure and precautions as outlined in "1".

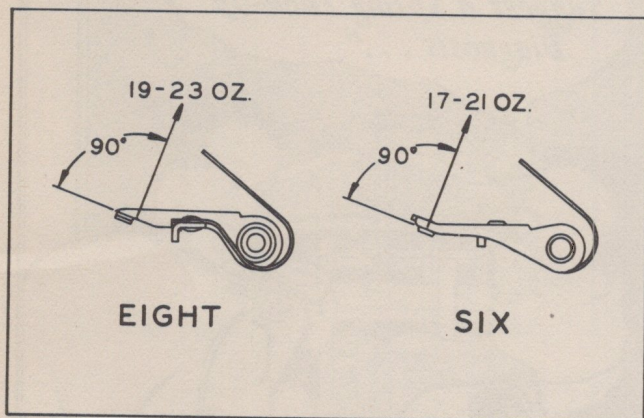
Fig. 3 Proper Location Points for Exerting Pull

These specifications are correct, however, the proper location point for exerting pull 90° to the breaker point surface is indicated by arrows in Fig. 3. The arrow for the 8 cylinder lever is at the side of the contact point, while the 6 cylinder has a lever extending out from the center of the contact point.

Because of the differences in construction of the breaker levers used in the 6 and 8 cylinder distributors, different spring tension specifications are required. The 6 cylinder lever is so constructed that a spring tension reading can be taken at a point directly above the center line of the contact point. Due to the construction of the 8 cylinder lever, the spring tension reading must be taken immediately adjacent to the contact point. This decreases the leverage and requires a higher specification than does the 6 cylinder lever. The resultant pressure at the point of contact of both 6 and 8 cylinder levers will be the same. Taking the measurement at different locations accounts for the difference in the specifications.

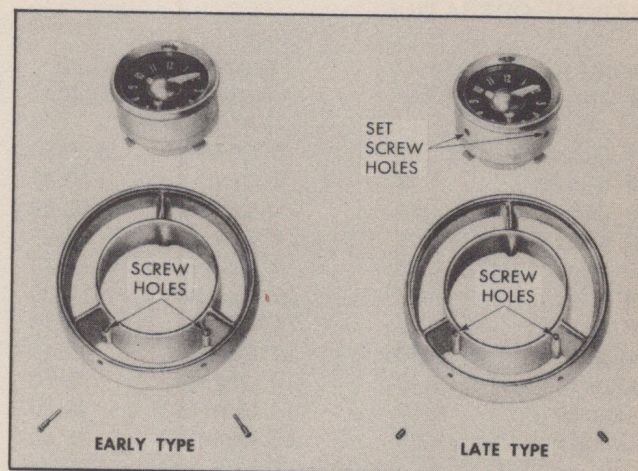
Fig. 4 Early and Late Type Clock Installation

Early 1951 electric clock installation was to hold the clock in position with two screws that applied pressure on tabs riveted to the rear cover of the clock. The screws for this purpose were located in the inner radio grille below the two lower grille ribs to the rear of the center hub. See Fig. 4.

Later 1951 electric clocks are held in position in the radio grille by two screws located below the two lower grille ribs near the front of the center hub (shown in Fig. 4). These screws extend through the center hub and hold the clock secure by registering with two drilled holes in the clock bezel.

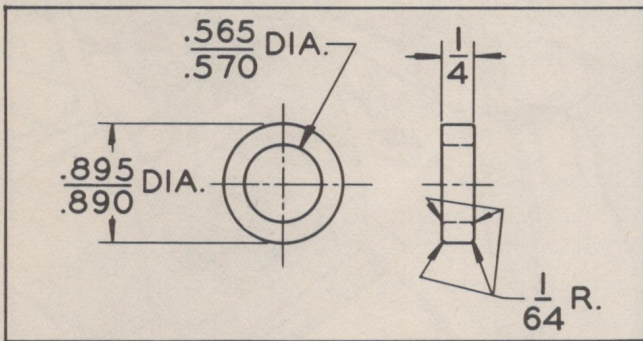
Fig. 5 Measurements for Making Washer

The rear spring bushings in 1950 and 1951 Pontiacs are a press fit in the spring eyes and frame. On some high mileage cars, it may be difficult to remove these bushings because of dirt or binding from corrosive action.

To relieve undue stresses and breakage of the draw bolt (J-4161-5) caused by a cocking or off-center pull on the bolt, a washer (Fig. 5) has been designed for use on the bolt to give relief from this condition. It is positioned on the bolt as illustrated in Fig. 6.

This washer can either be made at your dealership from cold rolled steel or equivalent, or purchased from Kent-Moore Organization by ordering J-4161-12 washer. The specifications for this washer are given in Fig. 5.

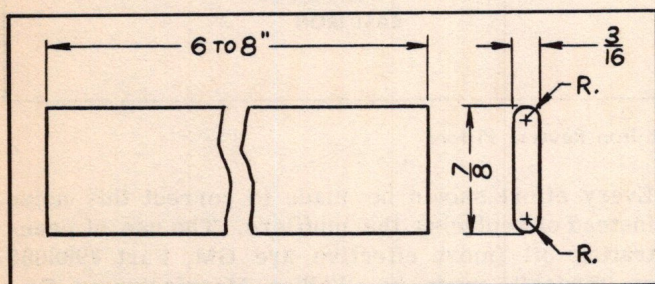
Fig. 3 Special Support Clamp Forming Tool

1. Apply a sharp blow with the palm of the hand to the underside of the visor at the center support. If support pulls off or is loose, remove the sun visor and re-work the center support as follows:

a. Make a special tool from steel stock as shown in Fig. 3.

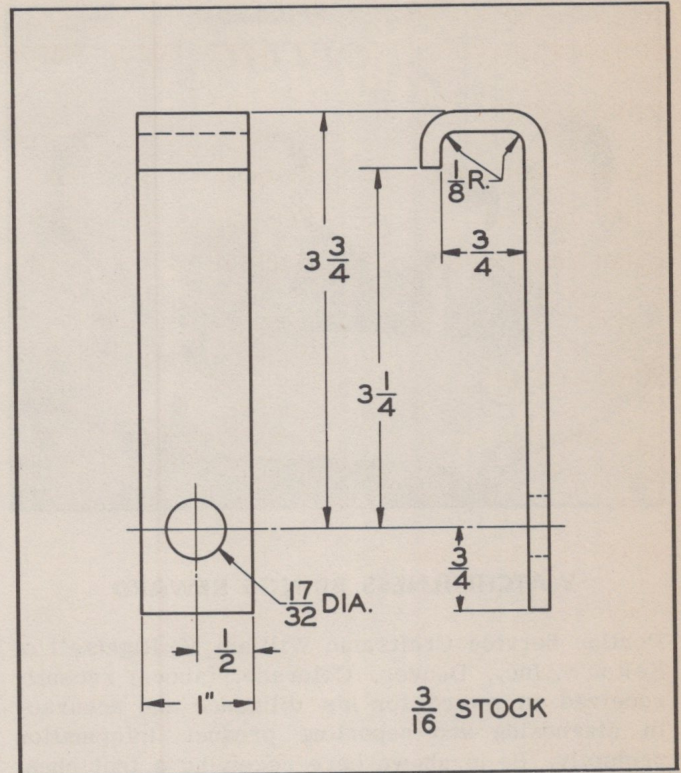
Fig. 6 Installation Tool

Most cases of squeaking brakes can be corrected by installing springs over the brake drums. A Brake Drum Silencer Spring Package has been released under Part No. 514278 (Group 5.810) and will be available at all zone warehouses. The package contains two springs and six spring retainers and can be used on either front or rear drums.

To assist in installing the brake drum springs, make four installation tools, as shown in Fig. 6.

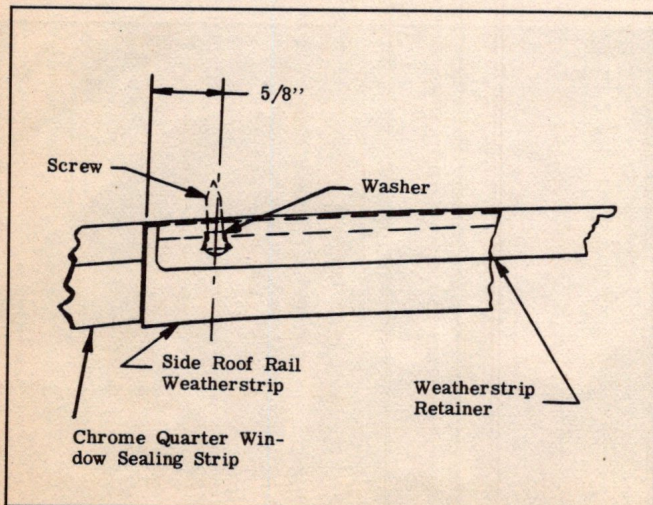
Fig. 8 Parts Identification at Side Roof Rail

Whenever cases are experienced where the side roof rail weatherstrip pulls away from the chrome quarter weather sealing strip, side roof rail weatherstrip may be held in the proper position (Fig. 8) by performing the following correction:

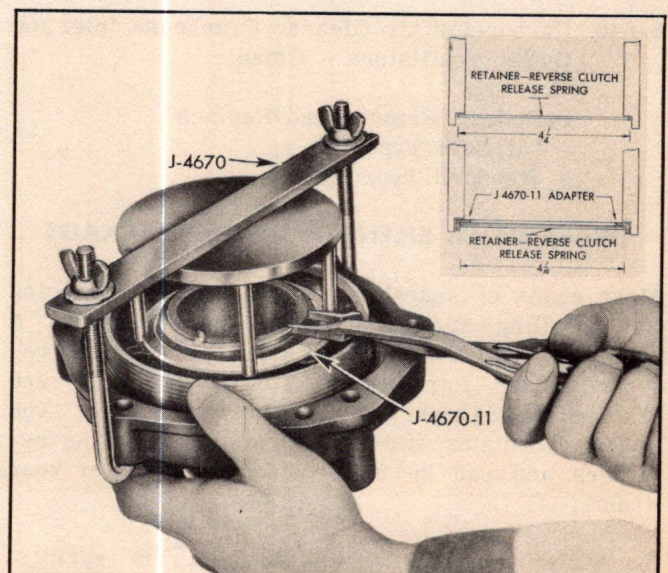
Fig. 10 Position of J-4670-11 When In Use

The outside diameter of the Hydra-Matic reverse clutch release spring retainer has been reduced from 4-1/4" to 4-1/16". This change will require the use of tool J-4670-11 to be used with special tool J-4670 (Fig. 10) whenever the new reverse clutch release spring retainer is encountered.

Tool J-4670-11 may be secured from the Kent-Moore Organization at the cost of \$1.00 net per tool.

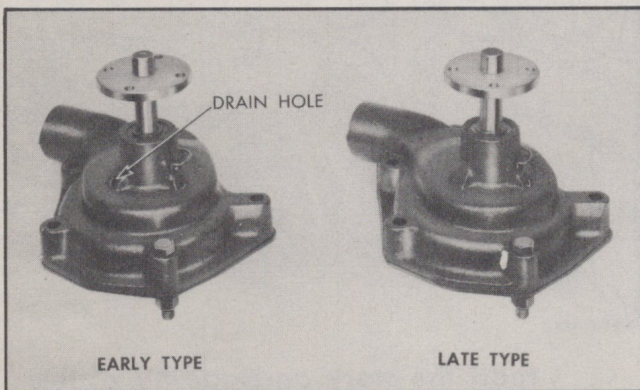
Fig. 3 Early and Late Type Water Pumps

Should a water pump develop a noise on idle, it can be lubricated by removing the fan and pulley and then filling the upper vent hole with engine oil. On early 1951 and past model water pumps which have a drain hole as shown in Fig. 3, the drain hole should be plugged with a bottle cork before the vent hole is filled. If the drain hole is not plugged the oil will drain off and the lubrication will not last.

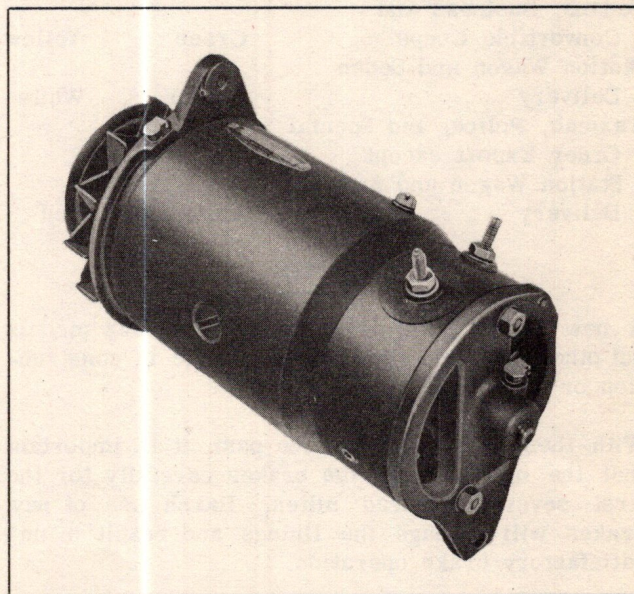
Fig. 5 New Extruded 45 Ampere Generator

A new extruded frame 45 ampere generator is being used on 1952 models. This generator model No. 1102769 has a new appearance and other structural differences (Fig. 5). However, it has the same armature and performance specifications as the late 1951 generator.

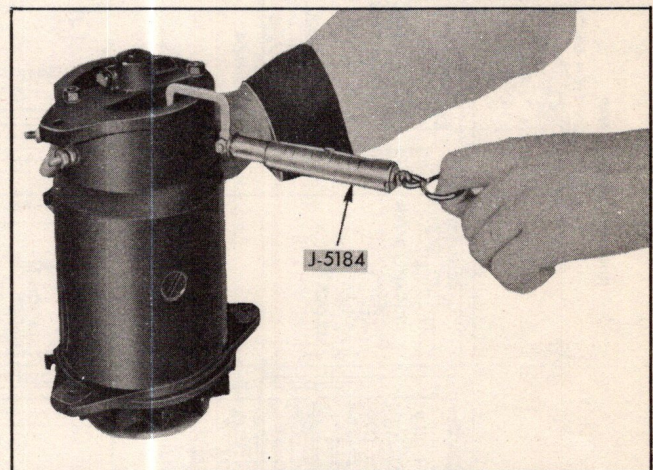
Fig. 7 Measuring Brush Spring Tension

The generator must be removed from car in order to check brush spring tension. With generator on bench, hook the end of the specially constructed spring scale J-5184 under end of brush tension arm next to brush and check tension reading as shown in Fig. 7. Spring tension should be approximately 28 oz. Correct if necessary by bending spring stop or installing new spring.

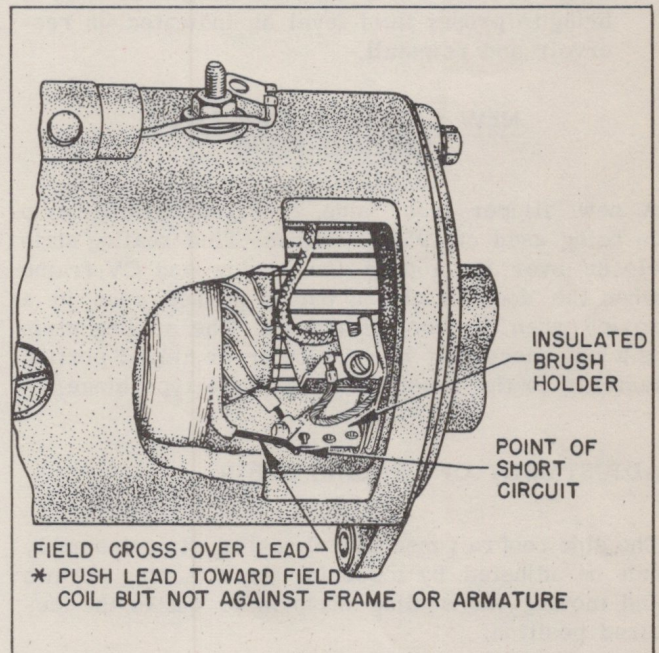
Fig. 17 Generator Field Cross-Over Lead

Generator models 1102750 and 1102775 on 1951 cars may have the field cross-over lead touching the insulated brush holder (Fig. 17). A short circuit at this point will cause excessive field current resulting in burned regulator points, high generator cut-in speed, failure to charge, and run-down batteries.

On any complaint of run-down batteries, remove the generator cover band and check the field cross-over lead to see that it is clear of the insulated brush holder. If the lead is near or touching the brush holder, push it toward the field coils but not against the frame or armature.

Where short circuits have occurred, always check the regulator points. Regulator points which have been only slightly burned should be cleaned or replaced and adjusted wherever possible. Follow procedure given on page 12-16 of the 1949-50 Shop Manual except that upper contact supports must be removed to permit thorough contact cleaning. If points are badly burned or welded together the regulator should be replaced.

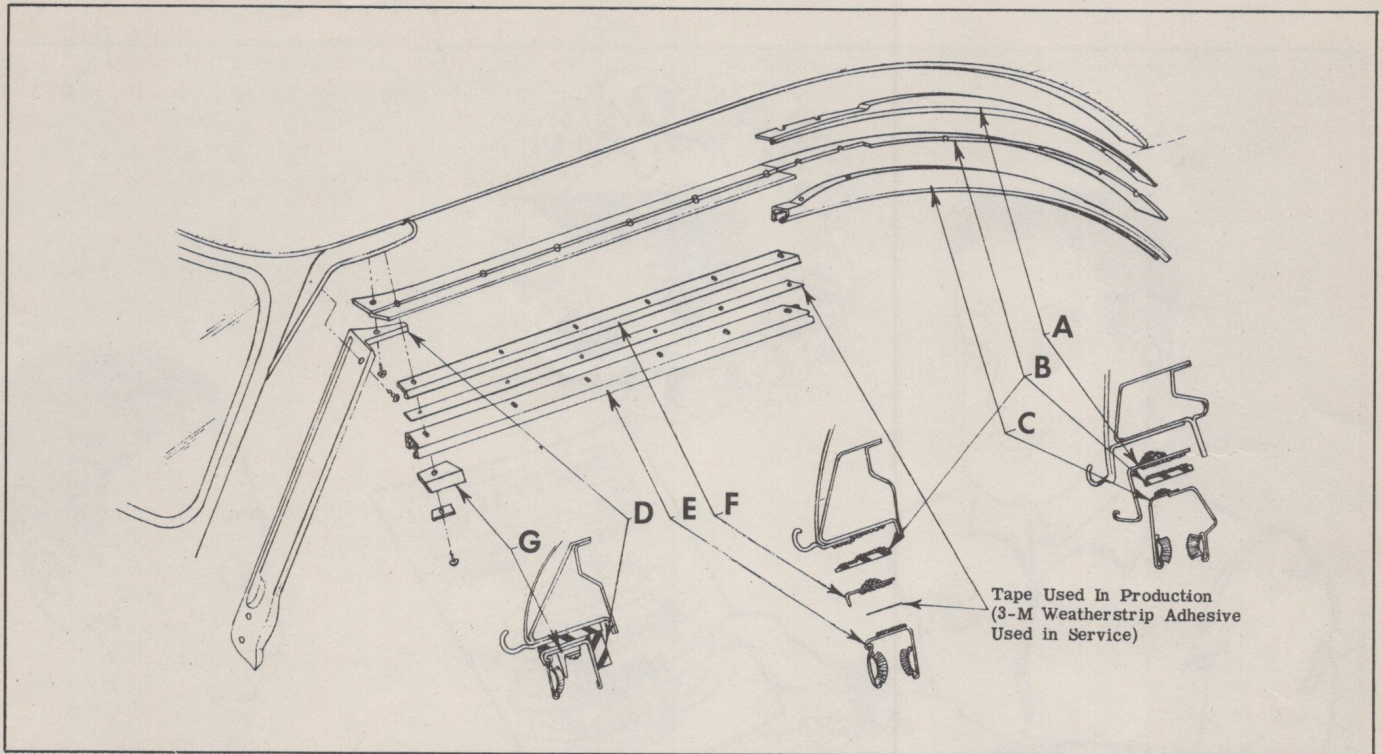
Fig. 18 Exploded View of 1952 Catalina Side Roof Rail Sealing Strip

The sealing strip assembly can be adjusted down by removing the assembly and shimmming between the side roof rail lower gasket ("F" in Fig. 18) and the side roof rail upper gasket.
